Starter Motor Repair

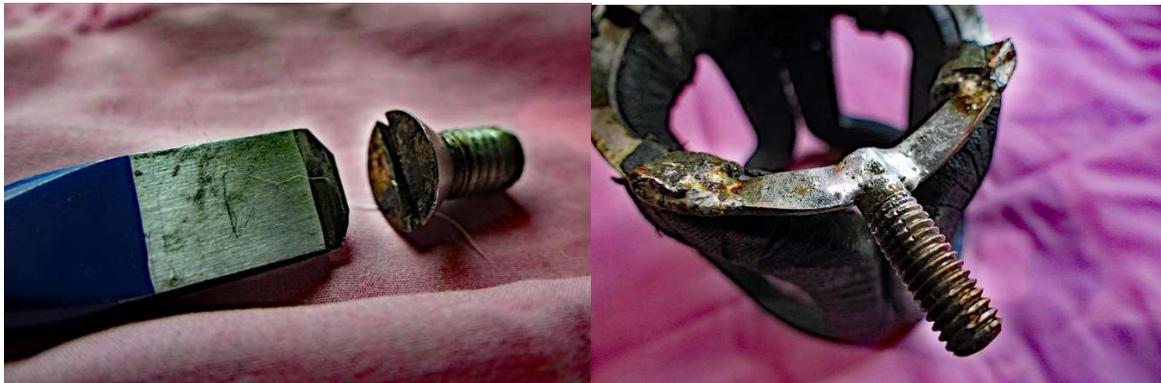
After reassessing the problem I noticed that the slot of the screw was much longer at the top of the countersink head than the thickness of any screw driver blade that would fit the screw slot the width of the blade was not much more than 50% of the total length of the slot.

I had been given a set of (Aldi) metal chisels including a range of standard cold chisels and selecting one that had the same width as the top of the screw I ground off the chisel point and squared the end so it was a neat fit in the screw slot with no side draft and then ground the 2 ends of this blade so it matched the slope of the countersink face of the head of the screw.

The shaft of the chisel was a hex and it was easy to use a large adjustable wrench and the screws came out very easily.

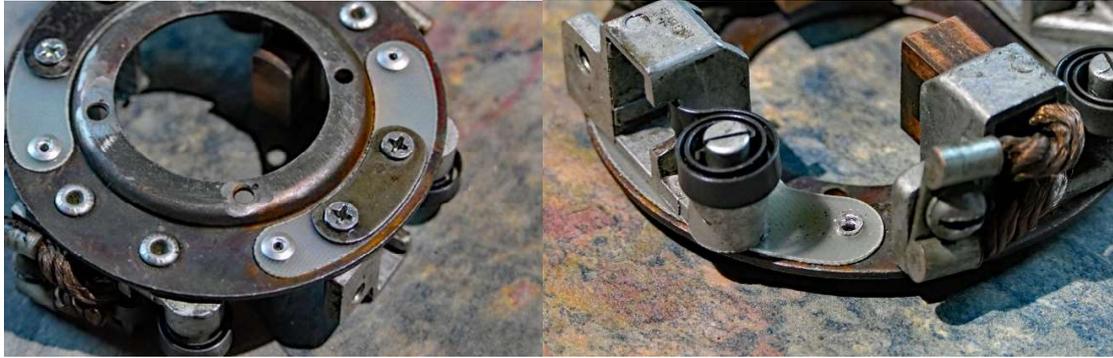
To assemble the brush holders and insulators into the brush holder plate I drilled and tapped a 1/8th BSW thread through the centre of the brush holder boss and with some careful fitting and counter sinking of the boss without destroying its fit into the steel support plates I fitted 1/8th Whitworth counter sunk screw. A good camming action was achieved.

To fix the outer ends of the insulators I used 1/8th aluminium pop rivets and by cutting rivet body to the required length on the pop rivet stem and the removing the stem provides a high strength hollow aluminium rivet which was set in place using a series of tapered point punches.

To refit the brush holder plate to the end cap I made a hollow point punch using a hi-tensile bolt drilling and the grinding the hole in the end to produce a reasonable shaped head on the brass rivets.
