CAN YOU FIX CREAKING AND CLICKING SPOKES ON A MODEL T FORD?

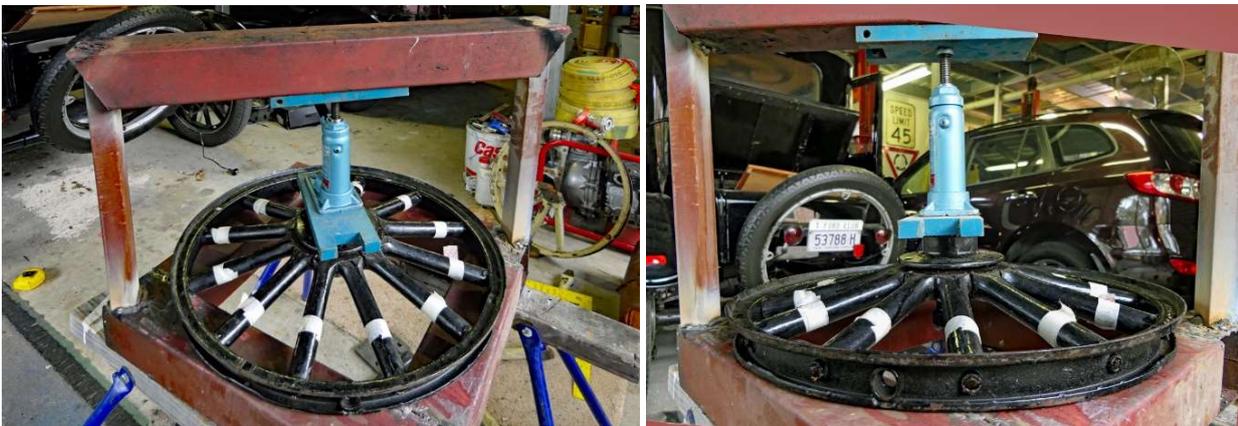
Not being sure of the pressure required to reassemble the wheel I built a press frame from some scrap square tube and left enough space to insert the small hydraulic jack I have in the back of my Model T. This has proved to have a far higher press capacity than is required to assemble the wood wheels.

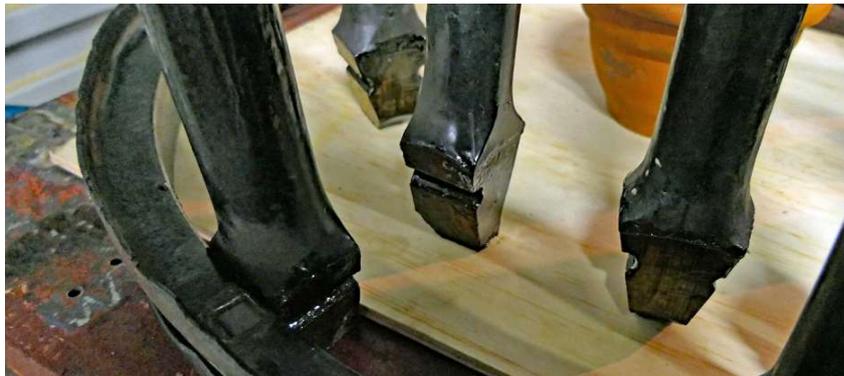
So how to expand the wedges so they form a tight pitch circle before the spokes bear heavily on the hub. I decided a fix was to paint the wedges on side to side contact faces as well as the faces that bear against the hub and hub plate, and the wedges inner end of the where they sit on the hub. The other end, the doveled or reduced end of the spokes that fits into the felloe, with a high-grade marine varnish and let this cure for 2 days.

I had numbered the spokes so I could put them back in the same place on the wheel and face the same way they were prior to their removal.

I also cleaned the metal of the felloe around the spoke hole and the circle where the spoke bears against the felloe and treated each area with a rust preventative paint and a topcoat of black. I also cleaned and repainted the hub and the hub flange plate.

I placed a piece of ply on my press and used a small flowerpot to allow me to form the spokes into a Tee Pee shape and check that I could push the hub into place. With the Tee Pee formed I could easily move the wheel without the spokes collapsing which allowed me to remove the flowerpot and sheet of ply before pressing the hub into place. As the spokes near horizontal I could feel the pressure reducing on the hydraulic jack. The reason for removing the sheet of ply is to allow clearance for the hub as it is pushed into place alternatively you need to pack up the felloe to provide clearance.

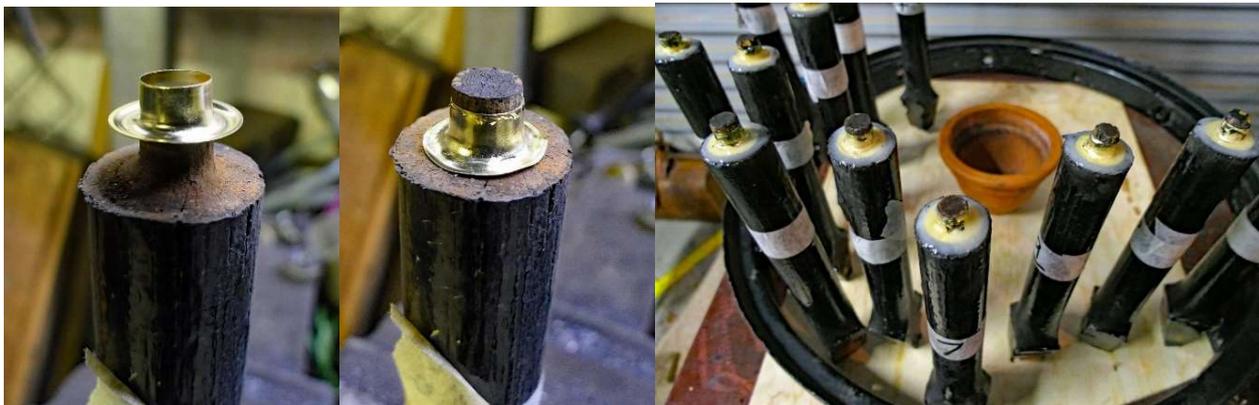
The offside rear wheel however was in much a poorer condition it had become noticeably loose on a long trip. I could get a 12 thou feeler gauge in between the spoke and the felloe at the top of the wheel.

I decided I needed to lengthen the spoke to offset the apparent wear at the end and I found a ½ inch Grommet repair kit in Bunnings and the brass grommet that fits the end of the spoke as if made for it. The grommet comes as part of an eyeletting kit but is in the tool shop because it comes with the setting tool.

These grommets force nicely over the spoke doweled end, but I added a coat of Araldite to the exposed timber but some of the Araldite spreads onto the face of the grommet. I also put 2 coats of Varnish on the taper ends.

I attempted to assemble the wheel, but I had clearly overdone the amount of correction, so I had to remove the Araldite on the face of the grommet with my electric file and sand the faces of the tapers before I could assemble the wheel with similar assembly pressure as the front wheels.

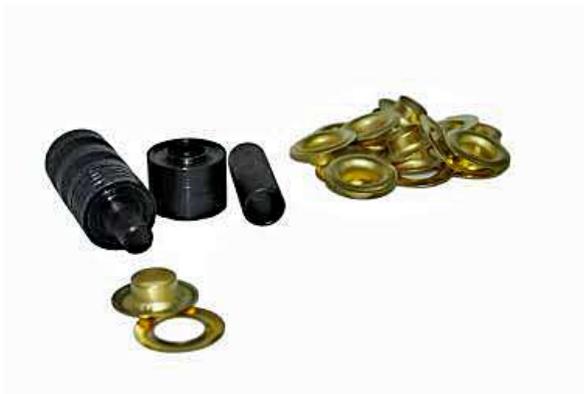
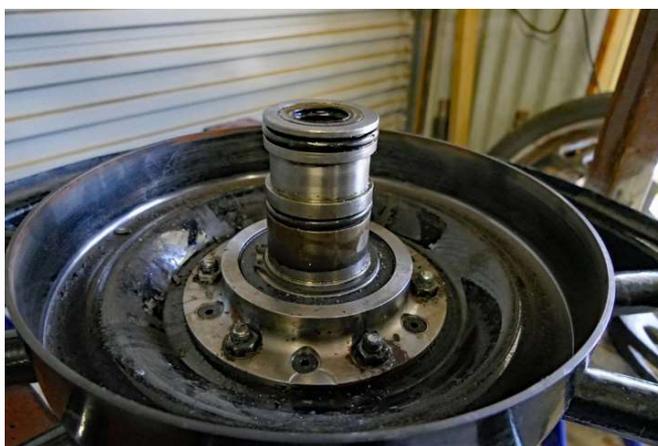
To remove the rear wheel, I had to pull the rear hub, and which includes the safety hubs that I had fitted, and I again appreciated the engineering that had gone into them. Last tip if you are having trouble releasing the hub with a centre bolt type hub puller, I found using my air rattle gun makes sure work of it but make sure the puller is tightly screwed onto the hubcap thread.
